# **Landslides in Sitka**

**Katherine (K.K.) Prussian, Hydrologist and  
Jacqueline Foss, Soil Scientist, Tongass NF**

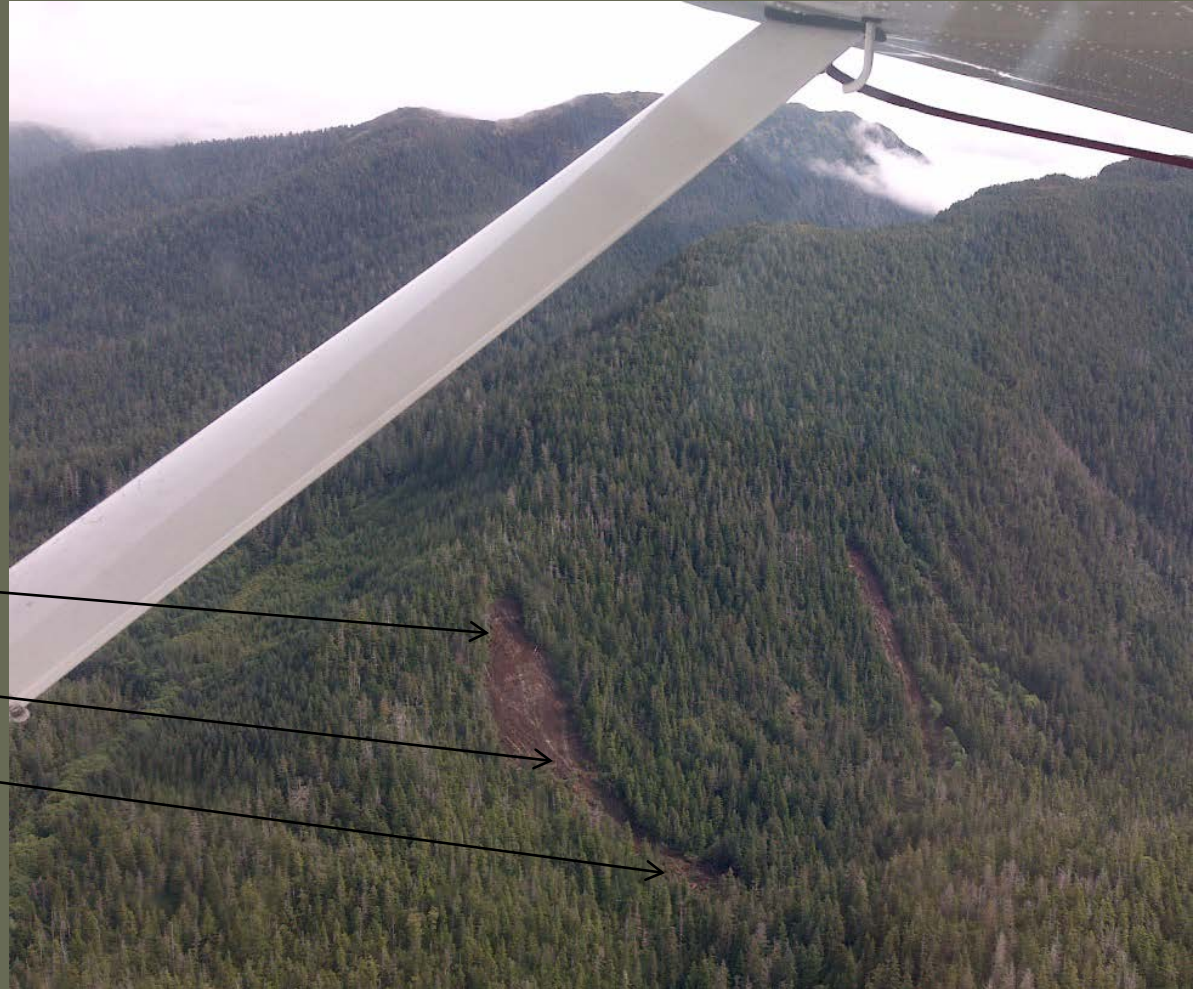
# Parts of a slide

- Initiation
- Runout
- Deposition

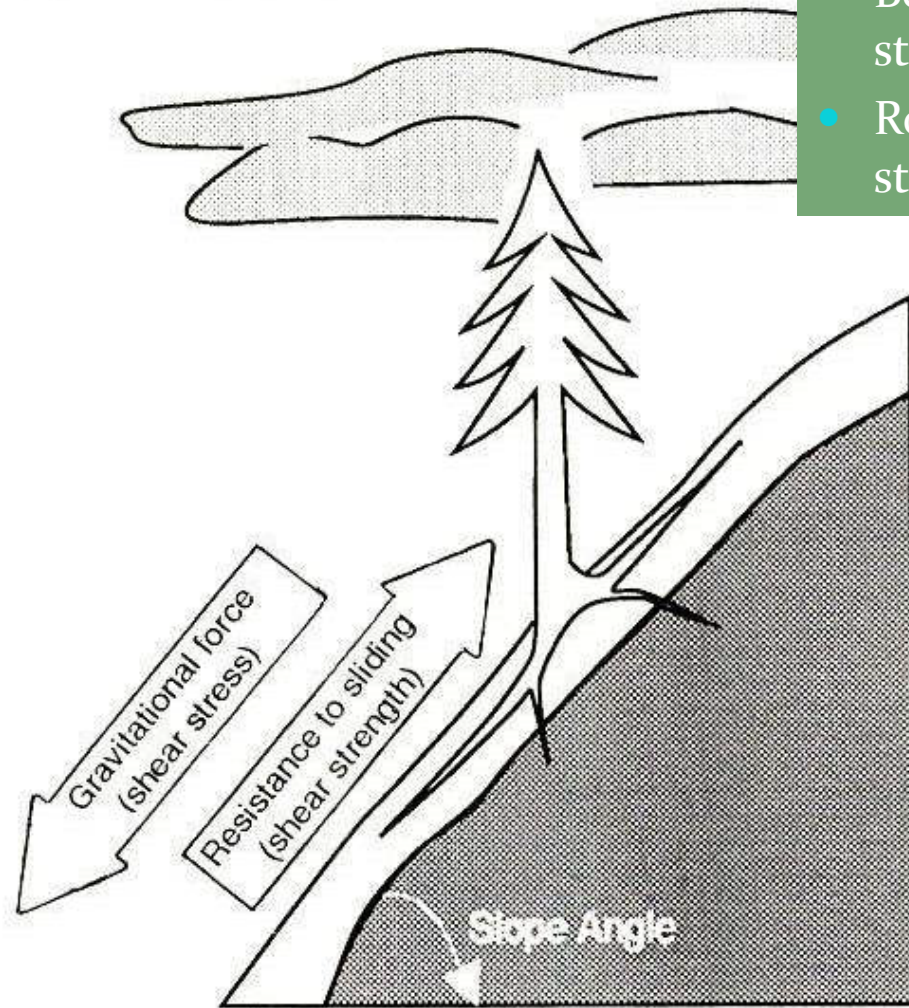
*Diagram of force acting on a vegetated slope*

- Weight of the hillslope material
- Slope
- Pore pressure

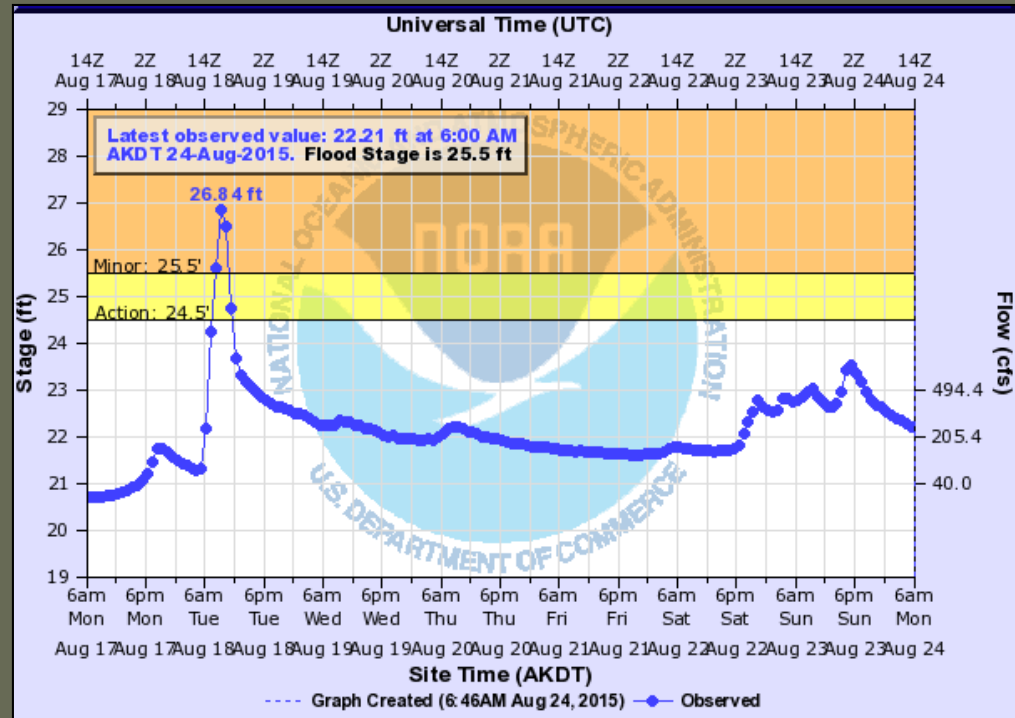
Indian River hydrograph.  
Two, 2-inch storms.

- Amount of rainfall
- Rate of rainfall
- Previous rainfall
- How does it move into and through the soil?

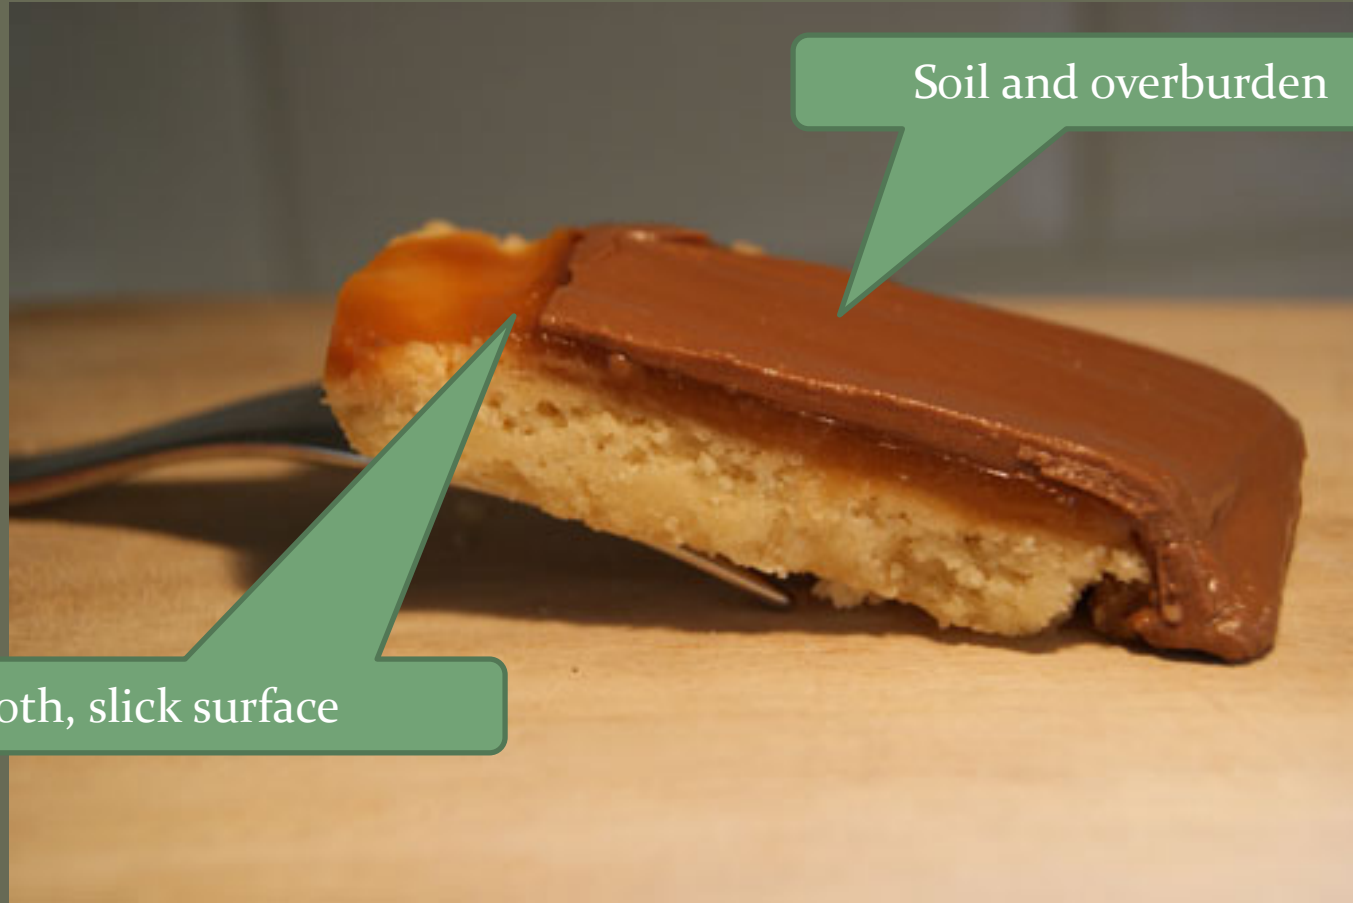
# Initiation

Slip plane - where water meets a smooth, slick surface

Soil and overburden

Smooth, slick surface

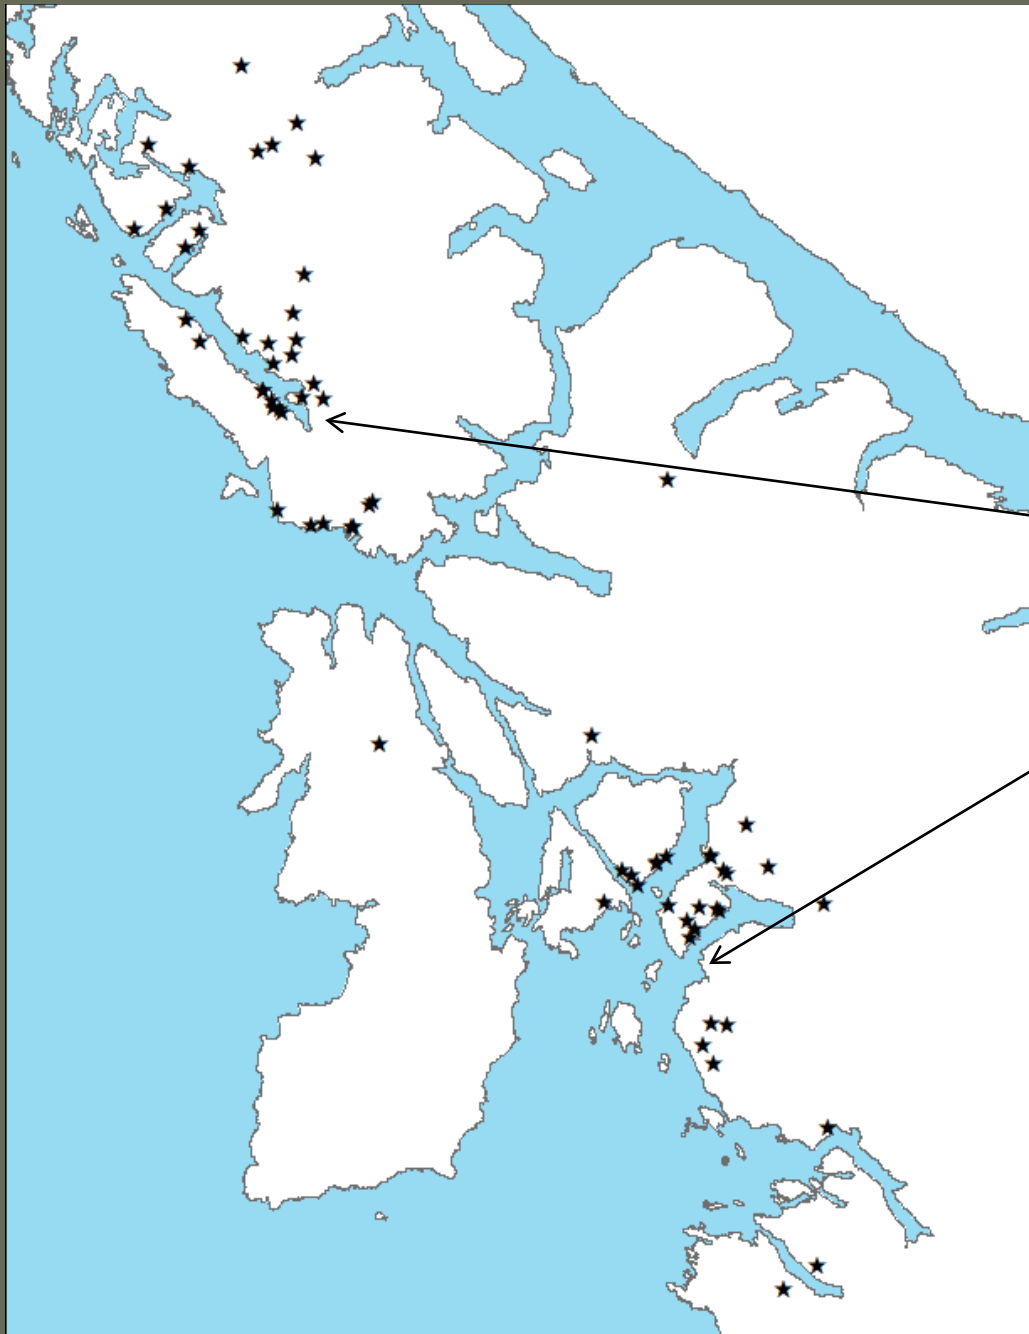
The August 18<sup>th</sup>, 2015, storm resulted in about 67 landslides between Khaz Peninsula and south of Sitka.

- Southern Southeast Alaska, November 1988 - 100's
- Prince of Wales, October 1993 - 100
- Prince of Wales, January 2014 - 35
- Sitka Area-Khaz Peninsula August 2015 - 67

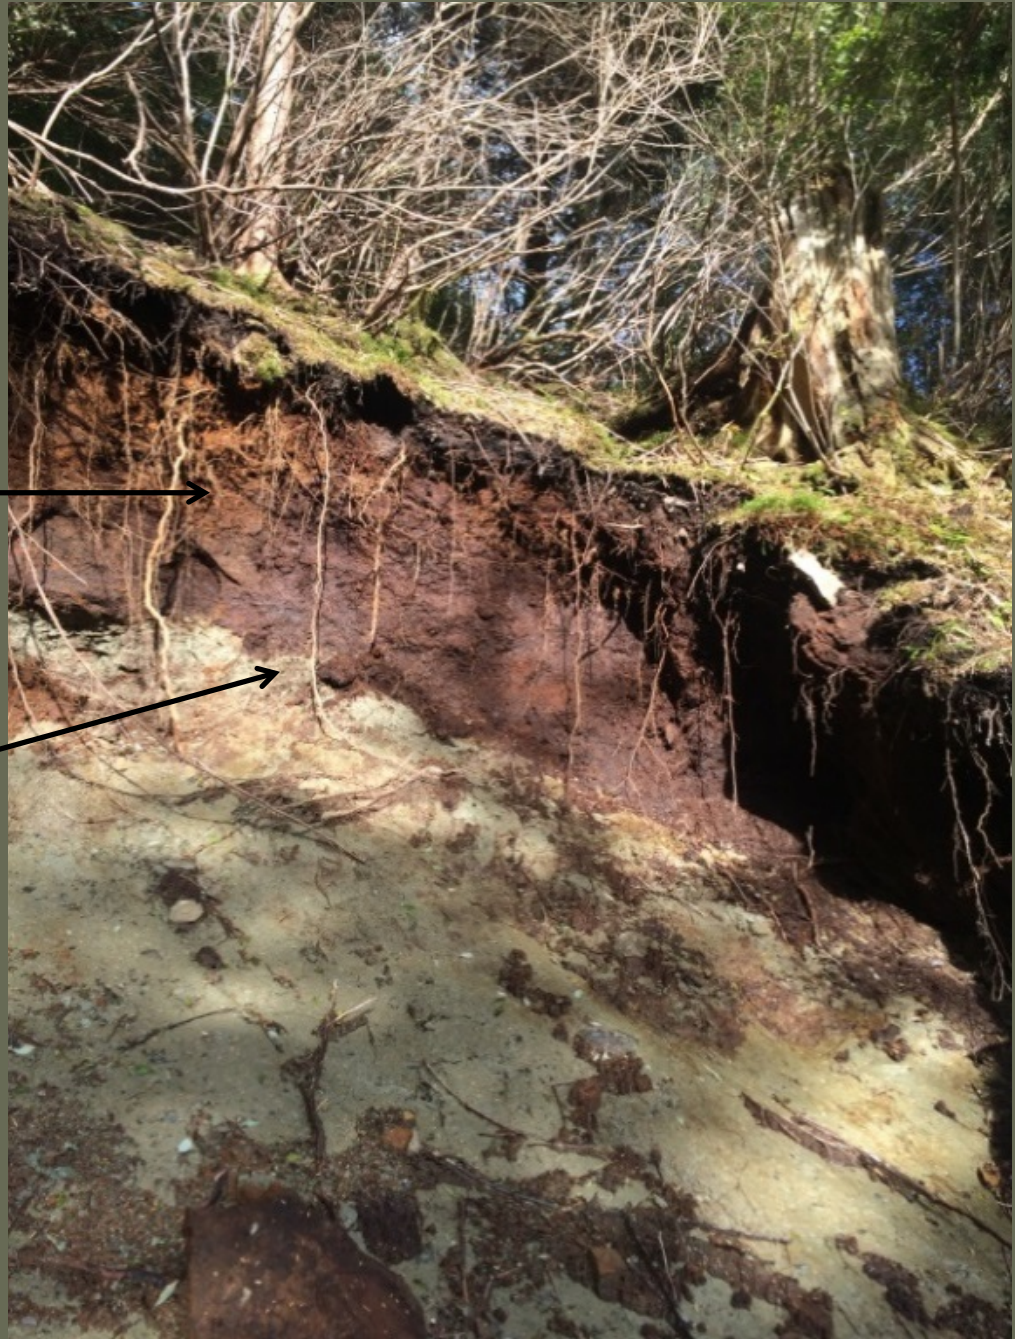
# Sawmill Creek

Ash to ash contact

Ash to till contact

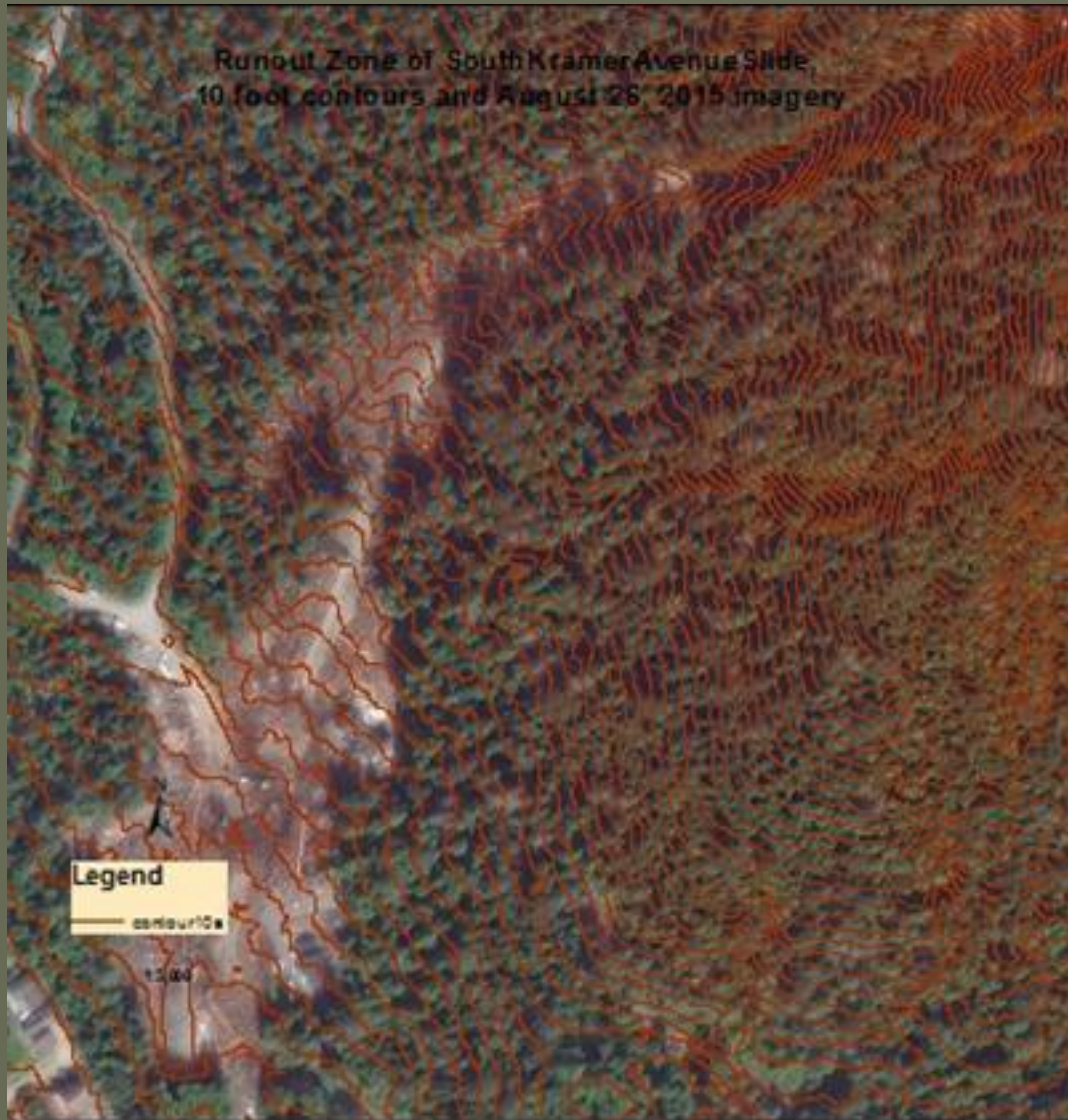
Runout Zone of South Kramer Avenue Slide  
10 foot contours and August 26, 2015 imagery

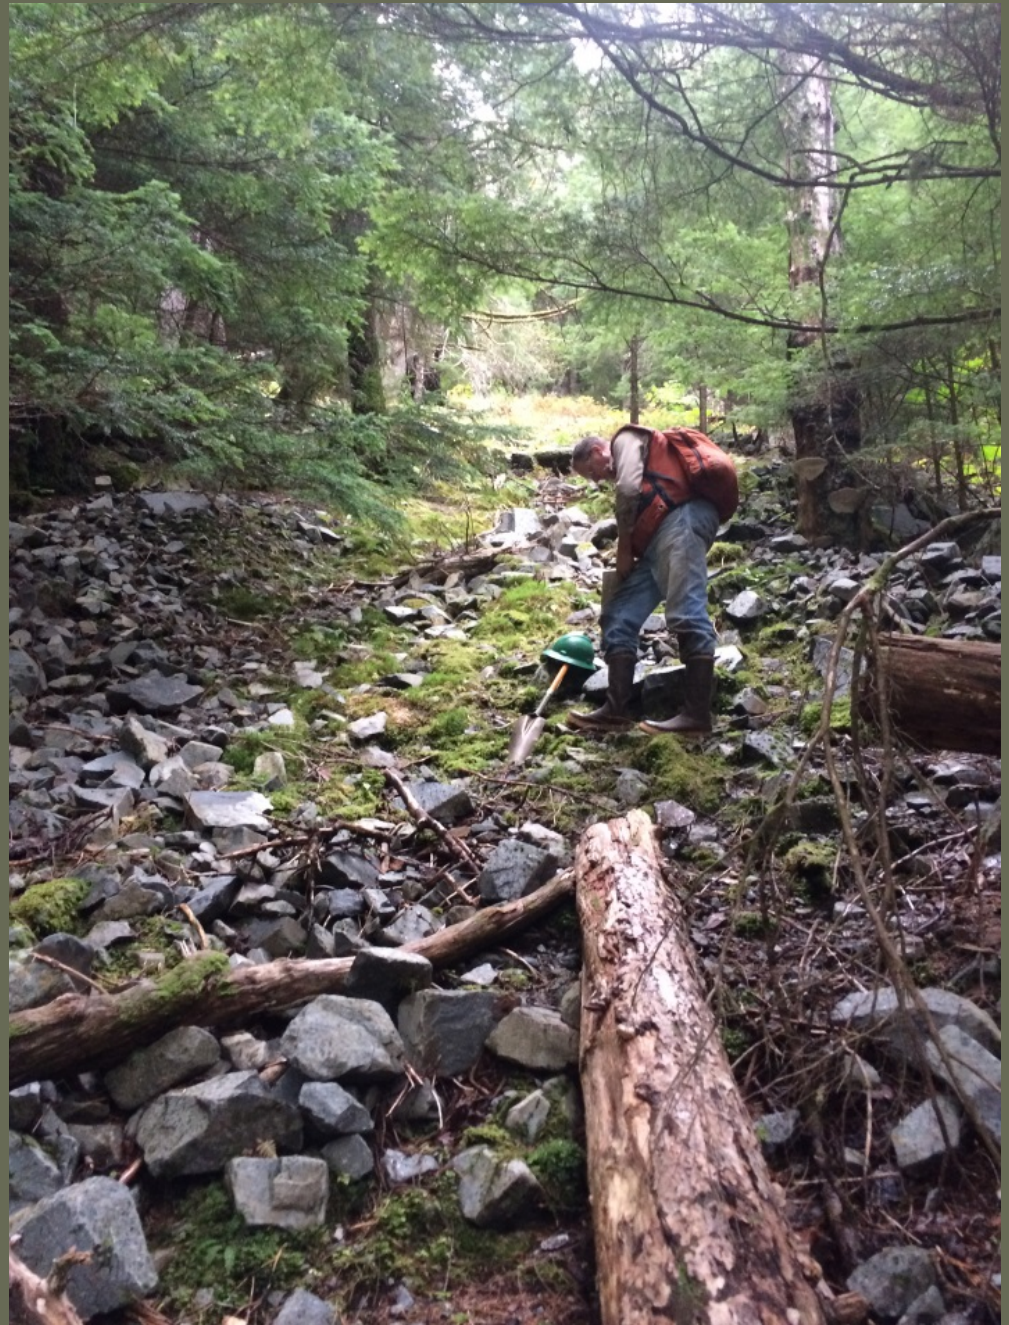
Past slides on hillslope  
between north and  
south Kramer

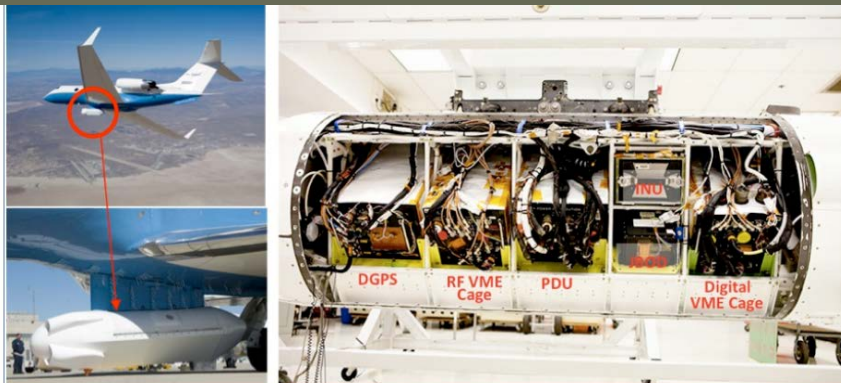
UAVSAR pod under the Gulfstream-III (G-III) aircraft (left) and the modular design of the pod electronics bay, which enables us to adapt the radar to operate in different frequencies with ease.

- NASA JPL Gulfstream III UAVSAR
- Airborne Radar
  - Interferometric Synthetic Aperture Radar
- Flew over Sitka 3 times
- Motion Detection - none
- Challenging environment
  - Not a good lab for this work

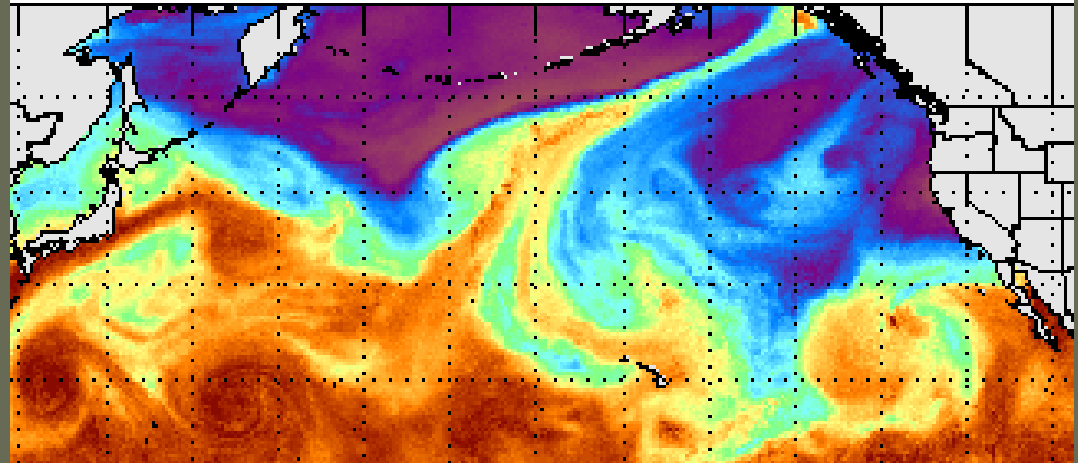
Morphed composite: 2015-08-18 10:00:00 UTC
