**SITKA SOUND
SCIENCE CENTER**

Sitka Geotask Force
Summaries
August 2015 Sitka Landslides

March 2016

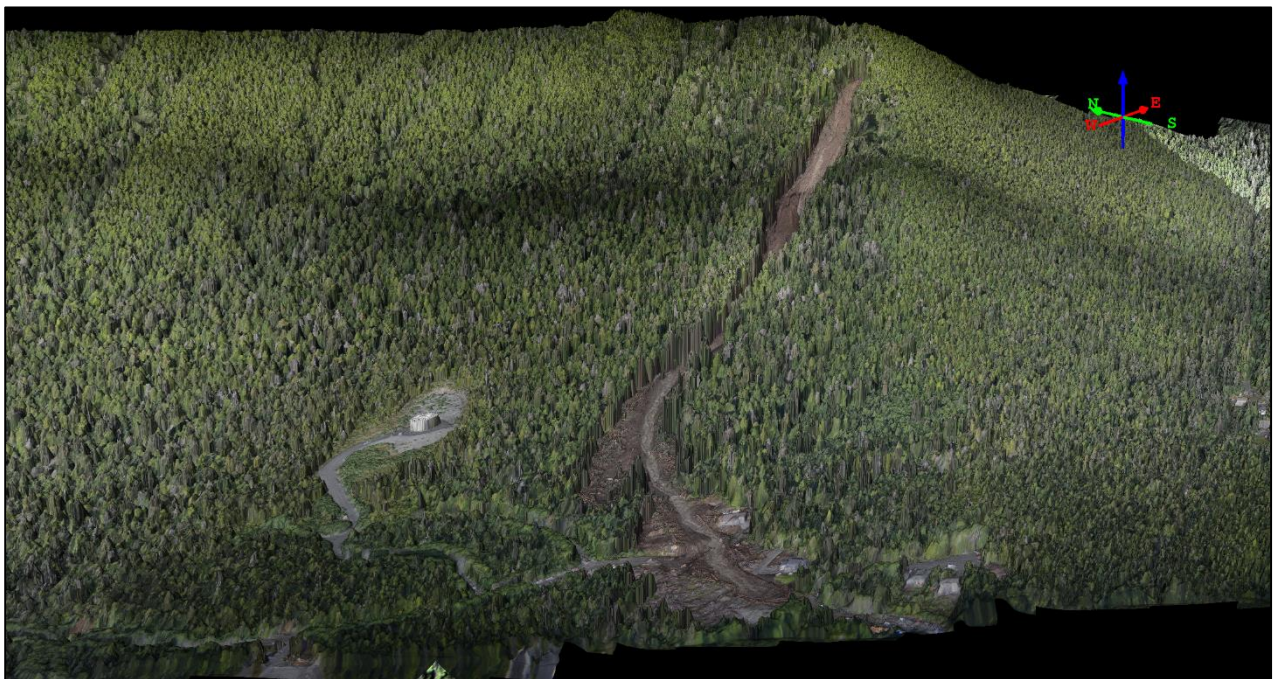
Figure 1. Orthophoto mosaic draped over the DSM created from SfM photogrammetric methods shows an oblique view of the South Kramer debris flow on August 20, 2015.

Following response work in Sitka, photographs from the aerial survey were processed using standard geodetic methods in combination with structure from motion (SfM) photogrammetric techniques to create a high-resolution orthophoto mosaic and DSM (see Fig. 1). These products allow for detailed debris flow analysis and are highly valuable because the photographs were taken two days after the events occurred. The orthophoto mosaic has a GSD of 0.07 m and the DSM has a GSD of 0.14 m.

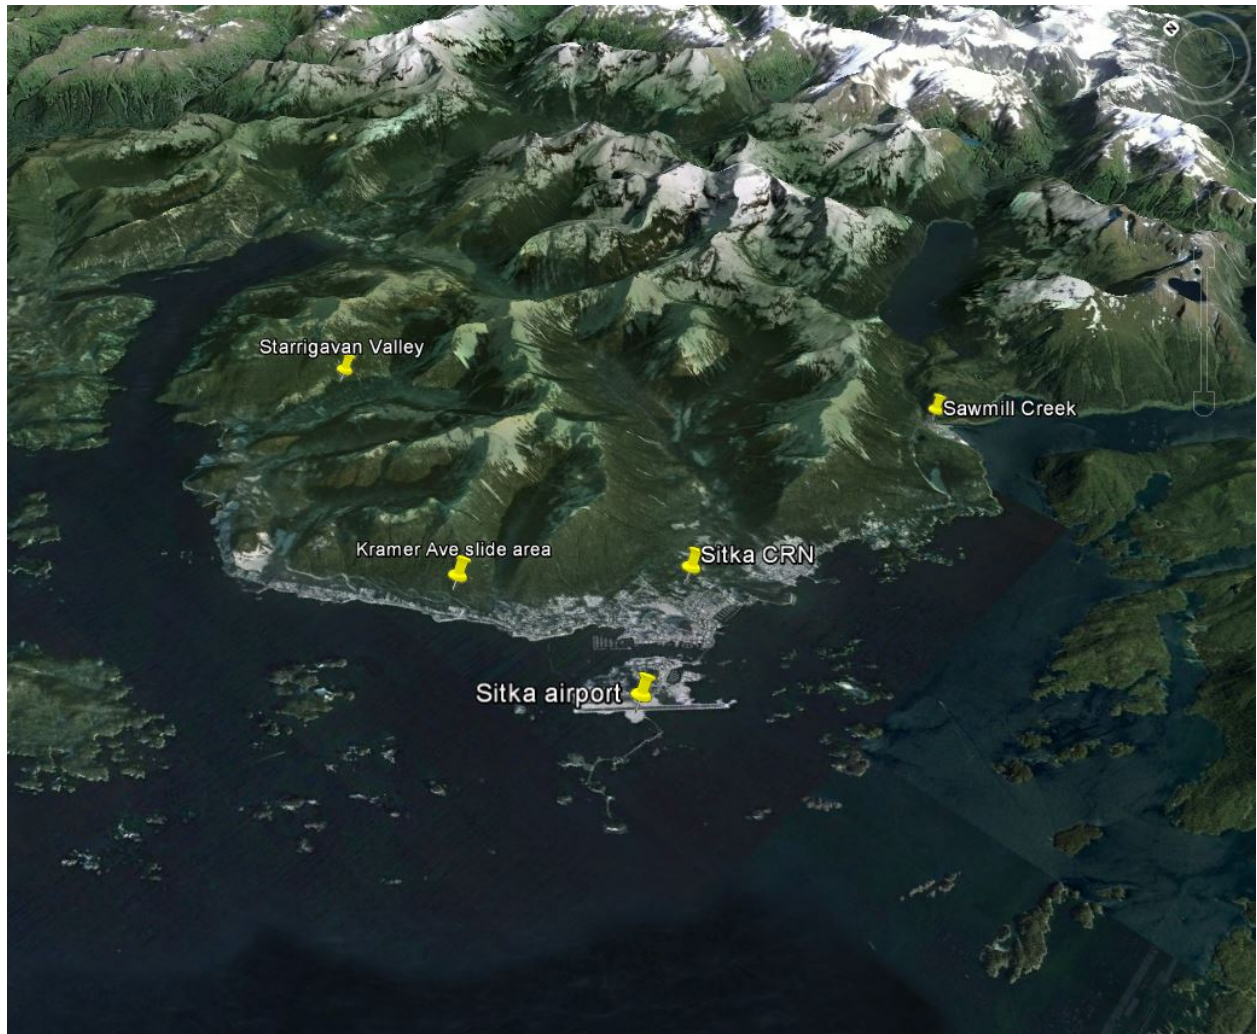
Figure 5: Topography of the Sitka area

The topography around the Sitka area and Baranof Island is very steep with mountains towering 3000 to 4000 feet in less than a few miles, (figure 5).

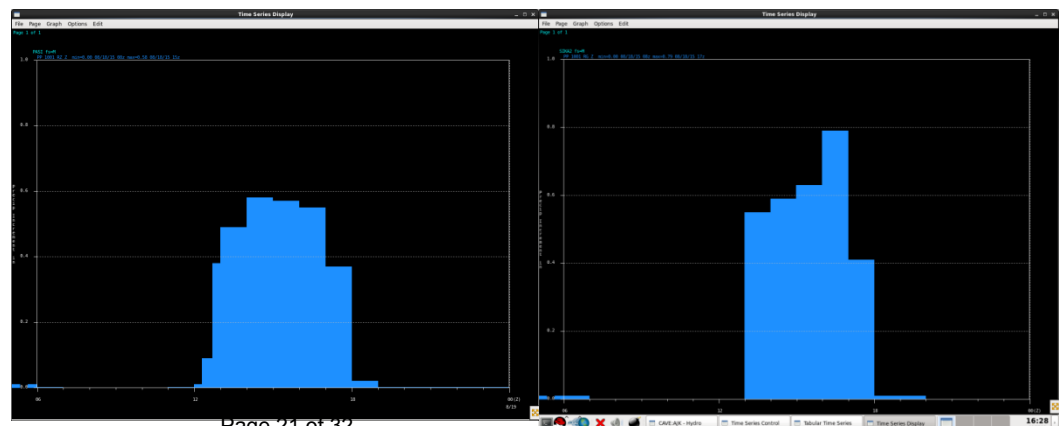
Figure 8: 1hr rainfall amounts from 4am-10am from Sitka Airport (right) and Sitka CRN(left)

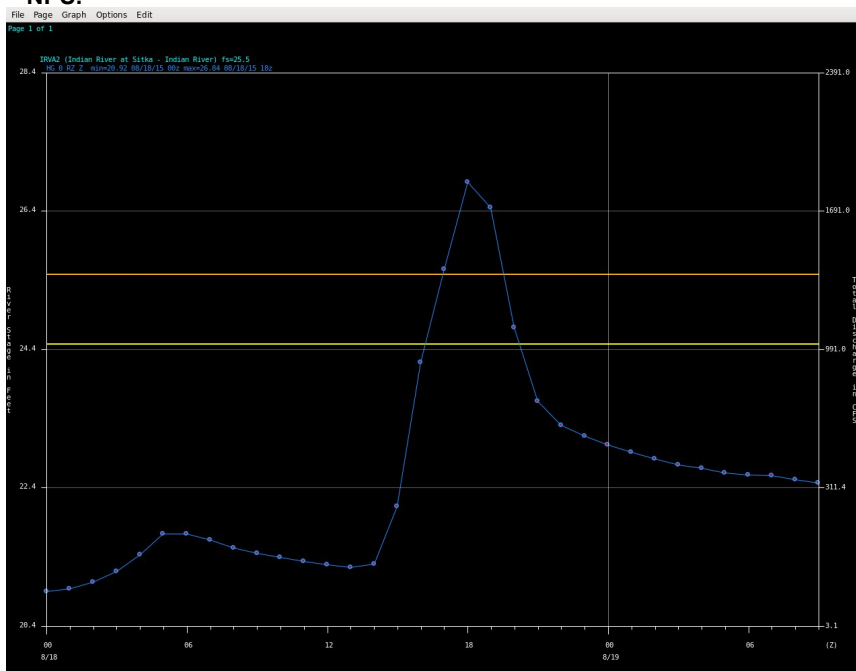
Figure 9 (above): Rainfall intensity return period from NOAA Atlas 14 Vol.7

Figure 10 (below): Indian River hydrograph from August 18, source NPS.

Rainfall intensities were a very big weather element that caused most of the impacts from this event in the Sitka area. Figure 9 shows how impressive these rates were. The 1hr rainfall return period at the Sitka Airport and at the CRN was notable with a 4 and 15 year return period respectively. The 3hr amount was extraordinary and the successive hours of very heavy rain caused the environment to react. The Starrigavan rain gauge and the CRN station had comparable rain amounts while the Sitka airport has less and much lower return period. This is again evidence that there was much more rainfall and higher rain rates at higher elevations due to orographic effects.

The rain came down so fast is caused the Indian River water levels to rise very rapidly. The river rose 6.8ft in 3 hours and crested at 26.84ft. This tied the record crest that the USGS reported October 19 1998 with a flow of 5,740cfs. The crest was more than 1 foot over the established National Weather Service's flood stage (orange line on figure 10). The weather front moved over the Sitka area between 930am and 10am as seen by the weather observation from the Sitka airport, figure 11. Once the rain stopped the river quickly receded and was back below flood stage in 2 hours. Also between the times the front went over the area there was a significant wind shift from south to southwest. Around that time Sitka's 911 hotline was getting calls about multiple debris flows across town.

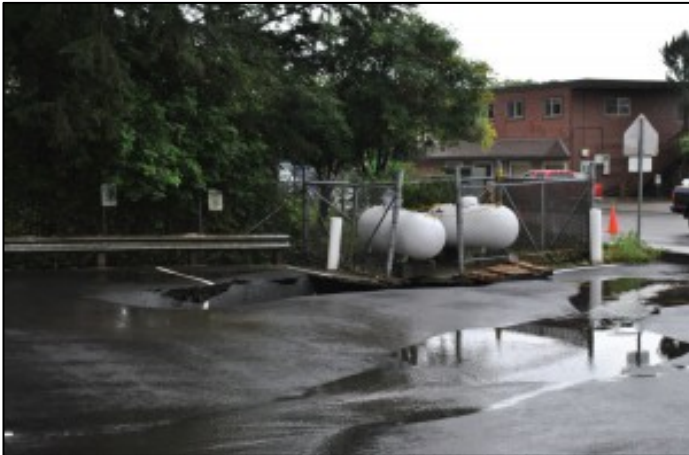
Photo 1- A sinkhole had opened up beneath a pair of propane tanks on Halibut Point Road. (Rebecca LaGuire, KCAW)

- The Indian River gauge crested at 26.84 feet at 10 am and tied the record stage from October 19th 1998. This stage was more than a foot above flood stage and did damage to area trails and around the Totem National Park.
- A sink hole developed and a propane tank was on the edge of going in.
- Numerous roads flooded.

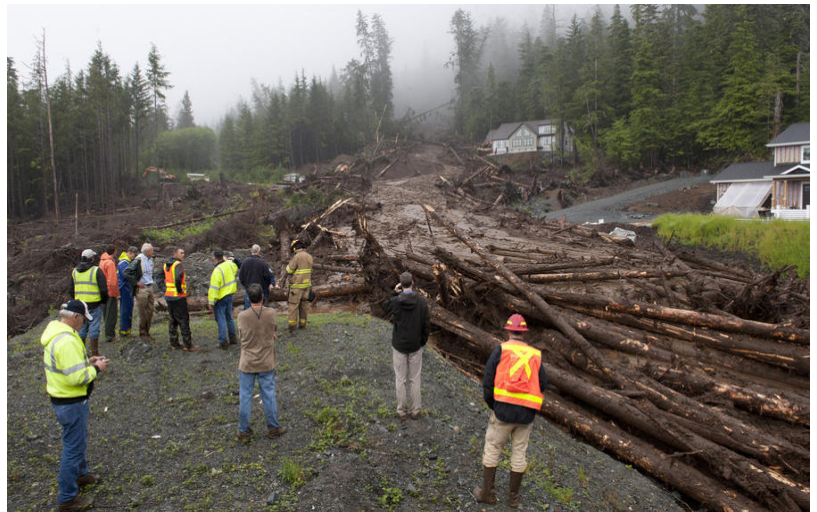
Photo 2- Kramer avenue debris flow.

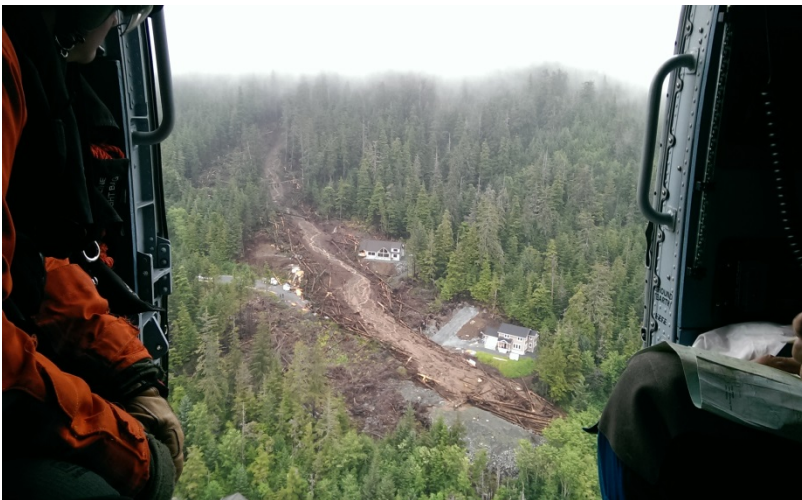
Photo 3- Aerial view of the Kramer Avenue debris flow. (Source: US Coast Guard)

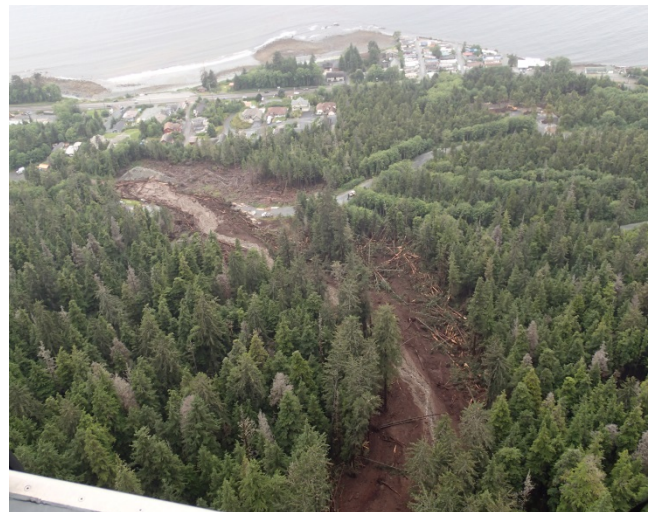
Photo 4 – Aerial view of Kramer Avenue debris flow. (Source: US Coast Guard)

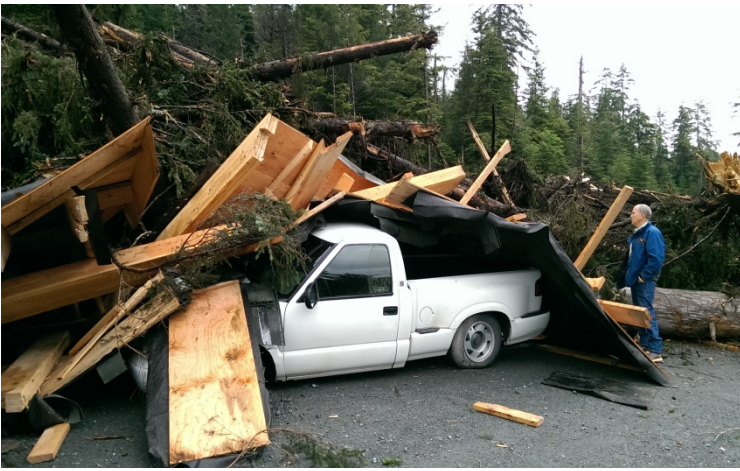
Photo 5 – Damaged done by Kramer Avenue debris flow. (Source: NWS)

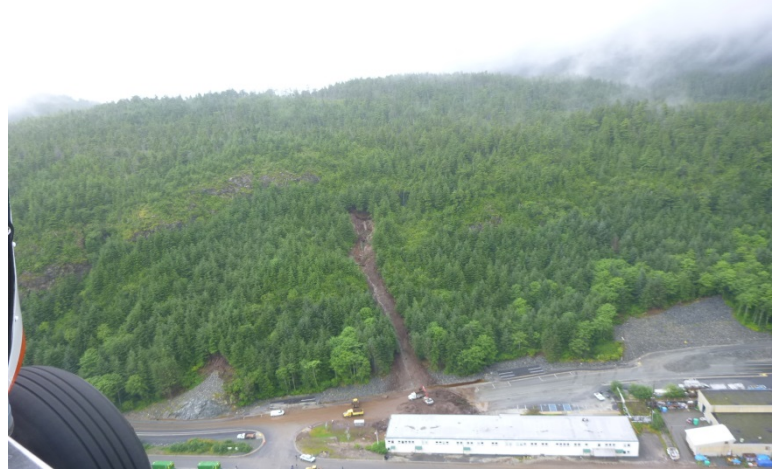
Photo 6 – Aerial view of debris flow at the Gary Paxton Industrial Park, (Source: US Coast Guard)

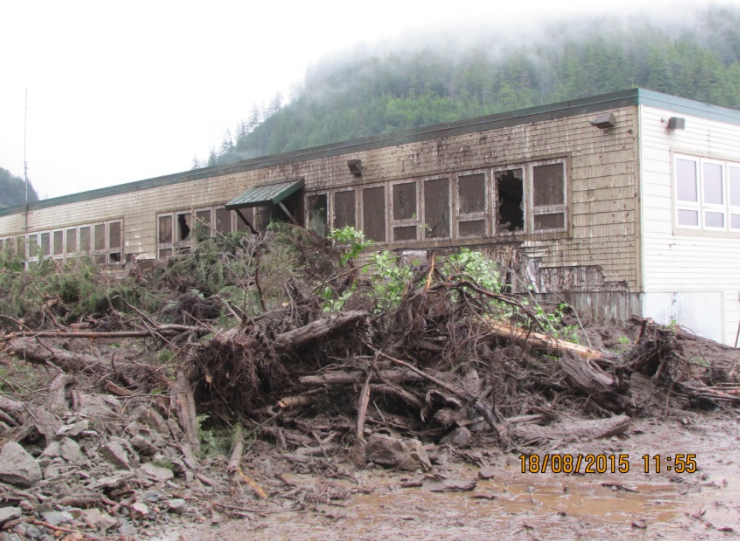
Photo 7 - damaged administration building at the Gary Paxton Industrial Park

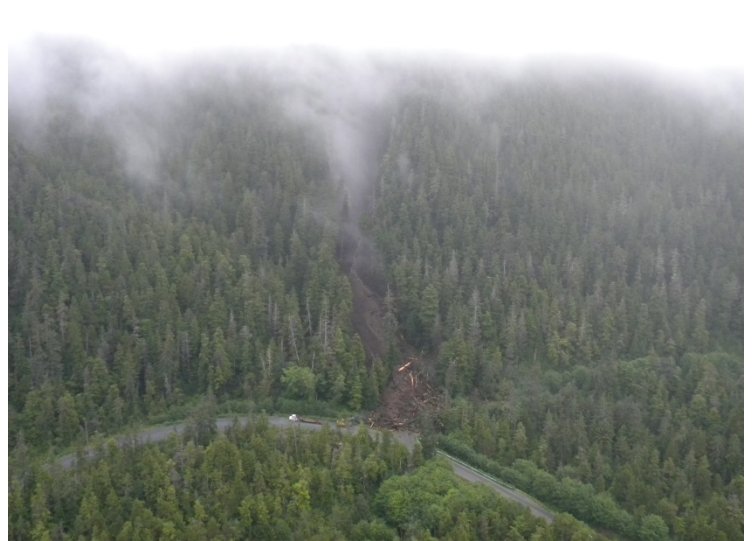
Photo 8-Other debris flow. (Source: US Coast Guard)

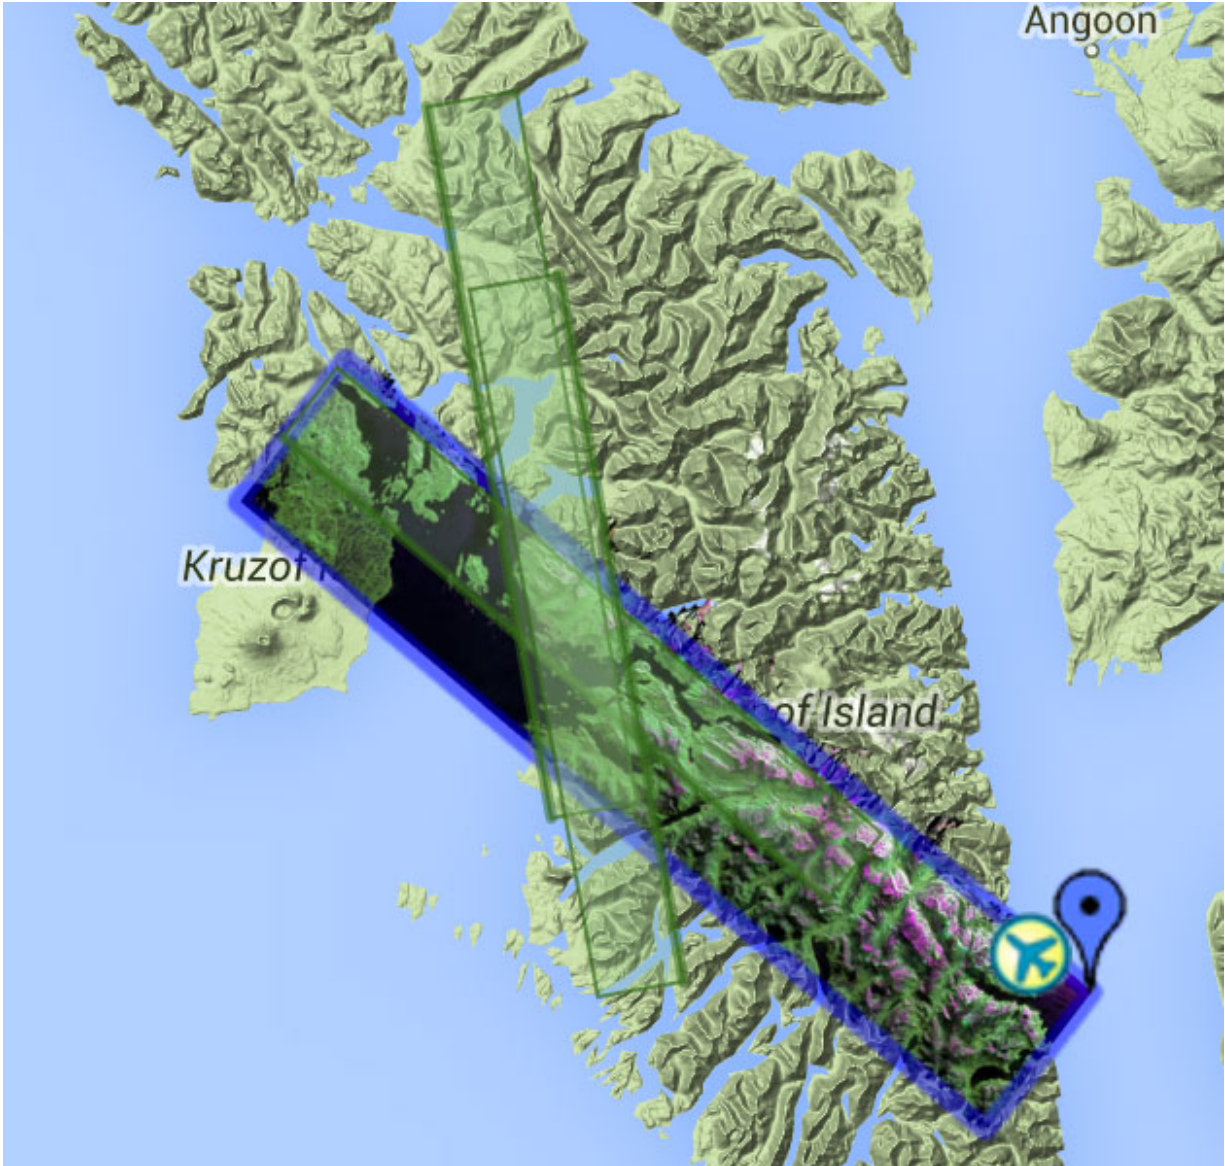
NASA flew the airborne radar system called AirMOSS, which is a P-band radar with about 68 cm radar wavelength, over Sitka on four flight lines. The flights were on 8/28, 8/31, and 9/30. One line was repeated on 8/28 and another line on 8/31, with time intervals of about an hour. The color images showing the radar reflection from the ground with different polarizations (called PolSAR for polarimetric SAR) are available from the Alaska Satellite Facility and can be found with either the ASF Vertex search tool or the JPL UAVSAR search tool (<http://uavsar.jpl.nasa.gov/cgi-bin/data.pl>). These are from the standard PolSAR processing of the AirMOSS data. All of the data is open to everybody. I attach a quick map of the flight lines from the UAVSAR search tool.

The JPL processing team also performed non-standard processing of interferograms between the 8/28, 8/31, and 9/30 acquisitions of AirMOSS data. The interferograms measure the change in distance between the ground and the airplane during the time interval between the images, so they are sensitive to surface motion. These interferograms are available from us at JPL and have no restrictions on use. We are planning to work with DG GS to get the interferograms into their archive for easier access, since we don't have a standard archive for these experimental products.

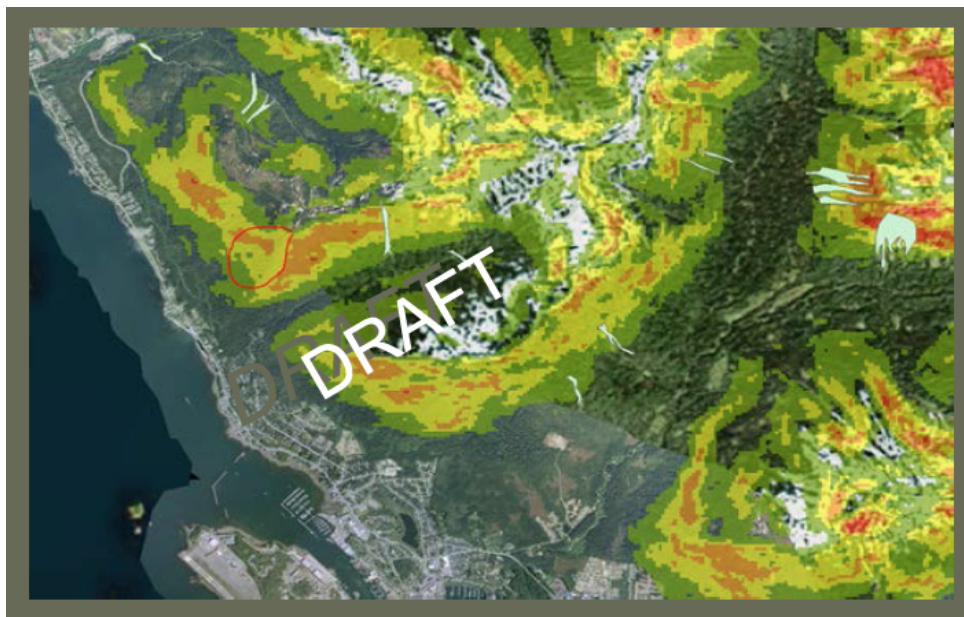
Figure 1. New landslide suitability map for southeast Alaska. Area around Sitka, AK, is shown, with the location of the Kramer landslide circled. Old landslides used in model construction can be seen in light green.

The landslides in Sitka in August, 2015, demonstrated the need to better characterize when landslides occur and identify high risk areas, not just in Sitka but throughout southeast Alaska. Research on characterizing landslides and where they occur was already ongoing, and the Kramer slides provided an opportunity to test the results. A regional landslide initiation suitability map was constructed using data from >750 landslides around southeast Alaska, as mapped by the US Forest Service. The map identifies locations on the landslide statistically similar to known landslide initiation points in terms of slope, aspect, local topography, and exposure to high winds. This map, at 30m resolution, is now available for the entire region and the associated publication is now in review. It is useful for identifying areas likely to experience a landslide, and does identify the Kramer area as a significant slide risk, though not in the highest risk category. A potential reason for this was the wind direction just prior to the Kramer slide, which shifted to a westerly direction; the landslide suitability model uses general wind directions from

the south (the predominant storm wind direction). Ongoing work with the National Weather Service hopes to create a dynamic model which can incorporate forecasted wind directions into warning systems, as opposed to the static risk map which was constructed. A major limitation is it does not map

runout zones, focusing only on initiation points, and is thus not a complete map of landslide hazard.
